PROJECT NO: 8.2752101 (B-3926) COUNTY: WATAUGA

## BRIDGE 35 WALL 1

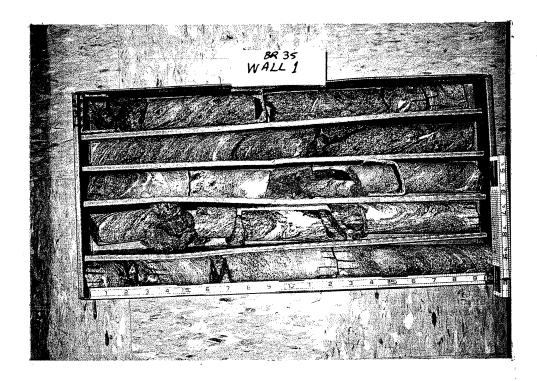
CORE 1: 12.1 – 17.9 CORE 2: 17.9 – 22.5 REC=90% RQD=66% REC=100% RQD=72%

LAYER 1: 12.1 – 22.5 Hard, slightly weathered amphibolite. Close-fractured, 40 pieces, longest piece 1.4 feet. Foliation and very thin layering dip 60 degrees, or folded in some places. 4 intervals with rubble where high- and low-angle joints intersect. 11 joints at 0-20 degrees, moderately rough, clean. 6 joints at 30-50 degrees, moderately rough, clean or coated with Fe-oxide. 4 joints at 60-90 degrees, smooth, clean or coated with Fe-oxide. REC=94% RQD=68%

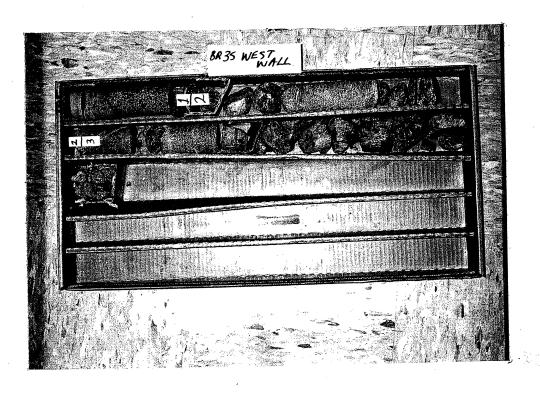
## BRIDGE 35 WALL 2

CORE 1: 7.0 – 8.1 CORE 2: 8.1 – 13.1 CORE 3: 13.1 – 17.2 REC=64% RQD=0% REC=40% RQD=9% REC=29% RQD=0%

LAYER 1: 7.0 – 8.1 Boulder

LAYER 2: 8.1 - 10.1 Probable boulders

LAYER 3: 10.1-17.2 Soft to hard, severely weathered to fresh amphibolite with seams of weathered rock and saprolite. Very close-fractured, mostly rubble recovered, longest piece 0.3 feet. REC=30% RQD=0%
